# Failure mechanism of ProTaper Ni-Ti rotary instruments during clinical use: fractographic analysis

**Spanaki-Voreadi AP, Kerezoudis NP, Zinelis S.** Failure mechanism of ProTaper Ni-Ti rotary instruments during clinical use: fractographic analysis. *International Endodontic Journal*, 39, 171–178, 2006.

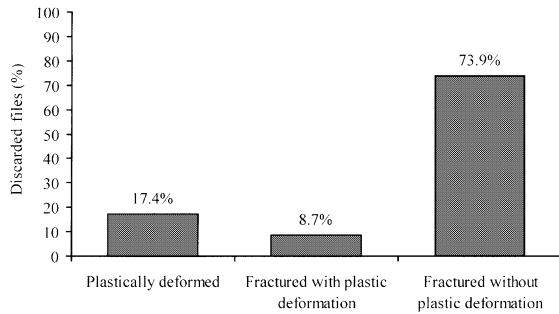
The results of macroscopic evaluation are shown in Fig. 1. From the discarded instruments, eight were plastically deformed (category A: 17.4%), four fractured with plastic deformation (category B: 8.7%) and the vast majority (34) fractured without macroscopic plastic deformation (category C: 73.9%).

**Figure 1** Percentage distribution of discarded instruments after clinical use based on stereomicroscopic investigation. The vast majority of ProTaper instruments (73.9%) failed without macroscopically evident plastic deformation.

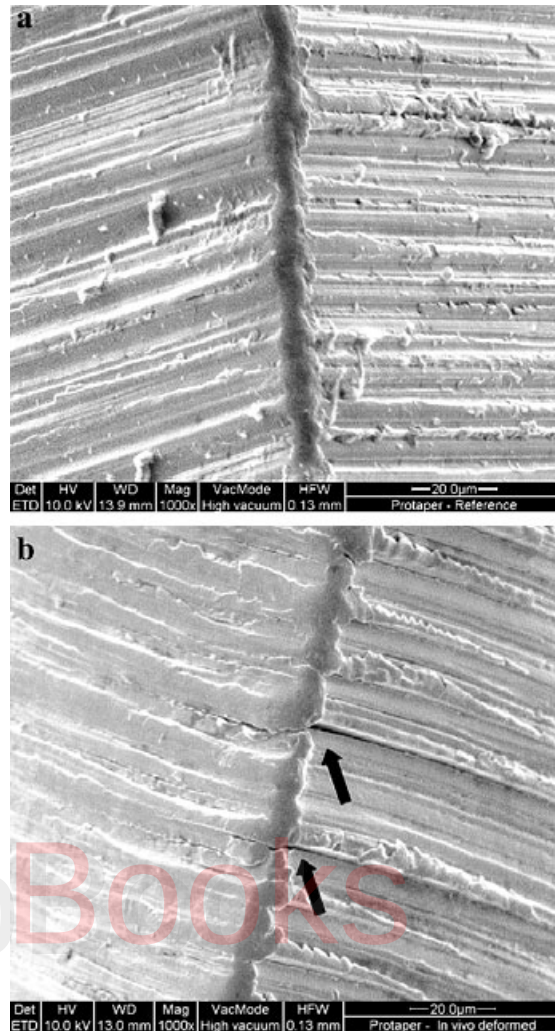
The SEM investigation of ProTaper instruments showed that some clinically deformed and fractured instruments presented surface cracks originating from the cutting edges of the instruments (Fig. 2b). However, the majority of the discarded instruments and all the unused instruments were free of cracks (Fig. 2a). Figure 3(a,b) demonstrate representative secondary

**Figure 2** Secondary electron images of the cutting edges of as received (a) and *in vivo* used instruments (b). A limited number of clinically deformed or fractured instruments demonstrate surface cracks at the cutting edges as shown in (b). (Original magnification 1000 $\times$ ).

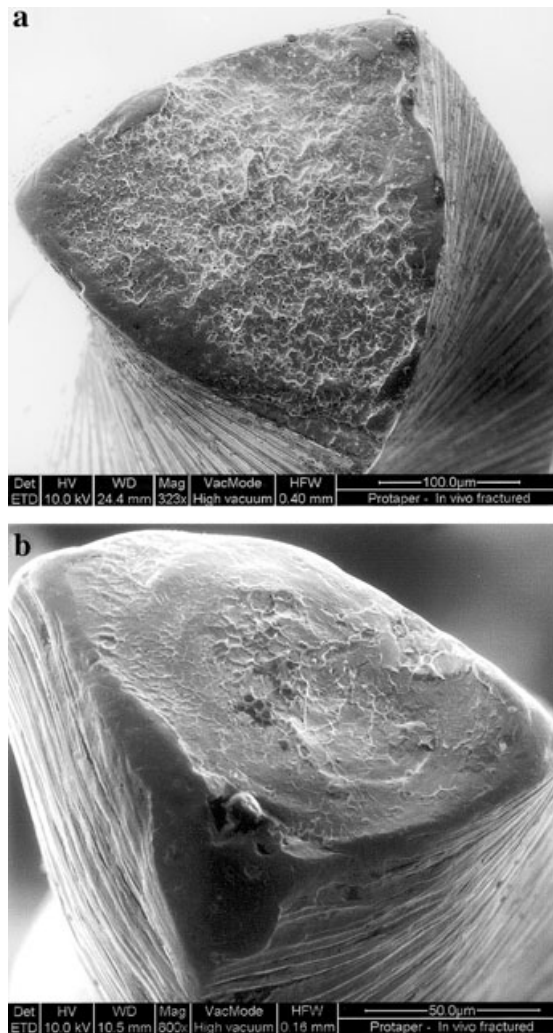
electron images (SEI) from the fracture plane of clinically fractured instruments showing the characteristic surface pattern of ductile rupture. No differences in surface texture were found amongst fractured instruments with and without macroscopic plastic deformation. In a limited number of five instruments, the fracture planes at the borders of cross section were at different levels from the main fracture planes. An instrument fractured in this way is shown in Fig. 4a. The characteristic surface pattern of ductile rupture predominates at the fracture plane, except from the upper and lower left corners where the fracture planes were located at different levels (Fig. 4b,c). Secondary cracks below the fracture plane are clearly observed in Fig. 4(a,b). Figure 4d depicts at higher magnification the central area, where the characteristic pattern of tensile failure (dimples and cones) coexists with the pattern of shear fracture (elongated dimples at a horizontal level). The latter are recognized as regions with flat surfaces. Figure 5a shows the fracture plane of a clinically fractured ProTaper instrument with a main characteristic pattern of ductile rupture, except from the left- and right-down corners, where the fracture plane was at a lower level. At higher magnification (Fig. 5b), surface striations appeared that were assumed to arise from fatigue failure mechanism originated from the cutting edge. This limited area of fatigue striations was the only evidence associated with the fatigue mechanism amongst all the instruments tested.

**Figure 3** a) Secondary electron images of clinically failed ProTaper instruments. Representative fracture surfaces of instruments with macroscopically evident plastic deformation (Original magnification 323 $\times$ ). b) Fracture surface of a instrument broken without macroscopic plastic deformation and much shallower dimples (Original magnification 800 $\times$ ).

The finding that some fractured instruments showed plastic deformation under stereomicroscopic investigation implies that at least these failed because of a combination of tensile and torsion overloading (Vander Voort 1987). This is also confirmed by the character-

istic dimple rupture patterns of the fractured surfaces (Kerlins & Phillips 1987) (Fig. 3). Although the appearance of failed parts is strongly associated to the loading conditions, this information is not enough to characterize the failure mechanism itself (Kerlins & Phillips 1987, Peng *et al.* 2005). The type of principal loading stresses, the origin of fracture, the extent of stress concentration factor, the effect of in-service environment conditions and other critical details used to determine the failure process can be defined only by standard fractographic analysis (Kerlins & Phillips 1987). Although the vast majority (73.9%) of discarded ProTaper instruments fractured without plastic deformation (Fig. 1), a behavior indicative of fatigue fracture, all the fracture surfaces demonstrated the characteristic pattern of dimple rupture without evidence of crack introduction and propagation. The fracture plane in 29 out of 34 fracture instruments without evidence of stereomicroscopically detected plastic deformation was oriented at an almost perpendicular level to the longitudinal axis of the instrument, showing dimple rupture without any characteristic of fatigue surface patterns (Fig. 3). This denotes that fracture was caused by a sudden overloading of the instrument rather than a progressive mechanical deterioration imposed by the fatigue mechanism. Another interesting finding was that the depth of dimples varied in extent (Fig. 3), which is in accordance to the results of Alapati *et al.* (2005) who found that clinically fractured Ni–Ti instruments demonstrated much shallower dimples than the laboratory tested stainless steel rotary endodontic instruments. This behaviour can be appended to the fact that the extent of plastic deformation is heavily constrained (Gillis & Gross 1985) by the high strain rates developed during the fracture by mechanical rotation of instruments during the chemomechanical preparation of root canals.

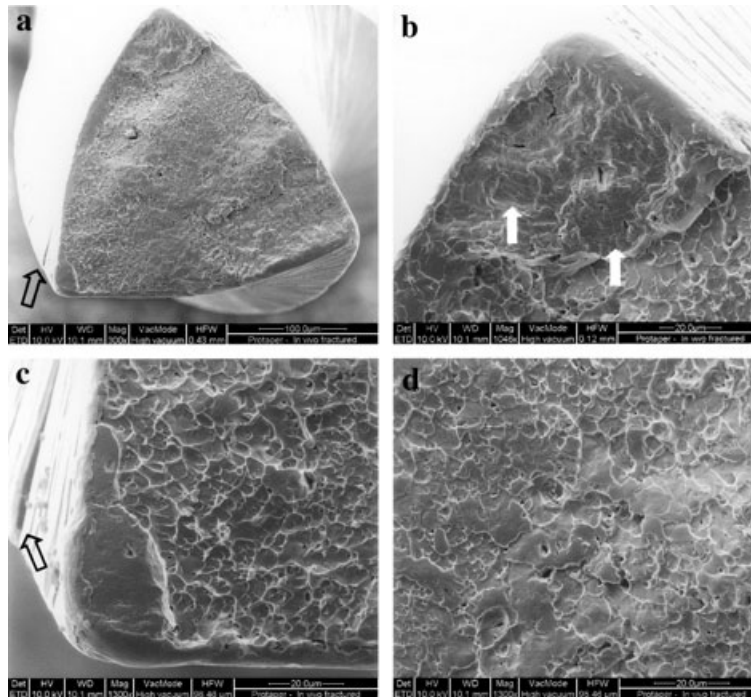
An other important finding was that five out of 34 fractured instruments, without plastic deformation, presented a fracture surface with different planes (Figs 4a,b and 5a). Additionally, these areas were very similar amongst each other as they resembled the sectors originating from the cutting tips. The location of these fracture planes at different levels from the main plane may be assigned to the fact that they are the last areas connected to the main fracture plane. This implies that although their presence decreases the mechanical strength of instruments, they may not contribute to fracture initiation. The presence of these sectors should be associated

**Figure 4** Secondary electron images from the fractured surface of a ProTaper instrument, a) Overall fracture surface (Original magnification 500×). The characteristic surface pattern with dimples and cones produced by ductile rupture is observed at the fracture plane, except from the upper and down left corners where the fracture plane is at a different level as readily shown in fig b (Original magnification 1046×) and c (Original magnification 1300×). A secondary crack is also shown in fig a and c. b) Elongated dimples are shown along the horizontal plane denoting that the fracture within the sector was caused due to shear overloading. In addition the typical deformation lines are hardly shown at this magnification (areas pointed by the arrows). Figure d (Original magnification 1300×) shows a higher a magnification of central areas whereas the characteristic pattern of tensile failure (dimples and cones) coexist with the pattern of shear fracture (elongated dimples in horizontal level) (regions with flat surfaces).

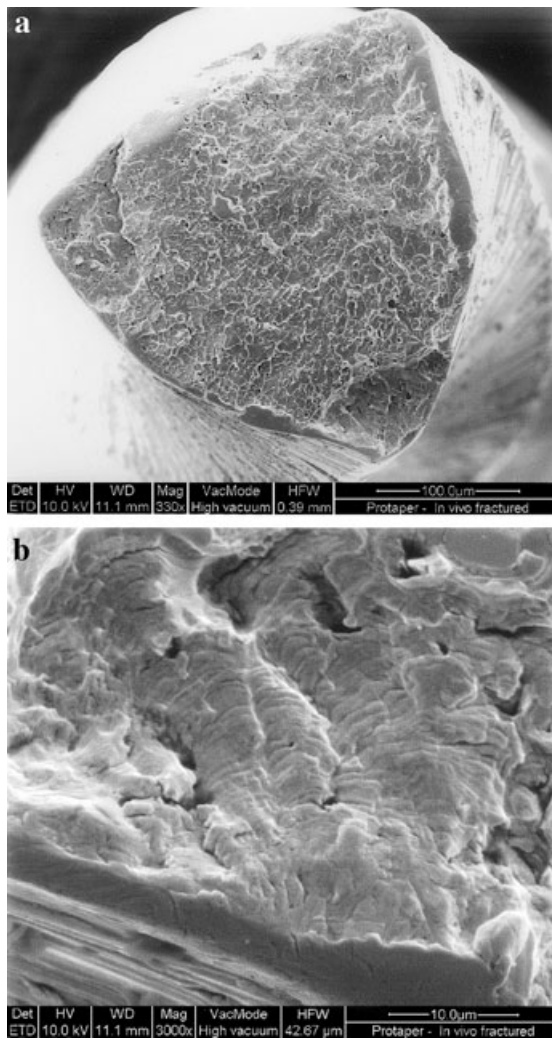
**Figure 5** Secondary electron images of clinically fractured ProTaper instrument. a) The fracture plane demonstrates the characteristic pattern of ductile fracture except from the left and right-down corners whereas the fracture plane is in a lower level. b) Higher magnification of surface striations assumed to arise from fatigue failure originated from the cutting edge. This finding of fatigue striations along a path of less than  $15\mu\text{m}$  is the only evidence associated with the fatigue mechanism among all instruments tested and thus it may be considered as a random finding (Original magnification  $3000\times$ ).

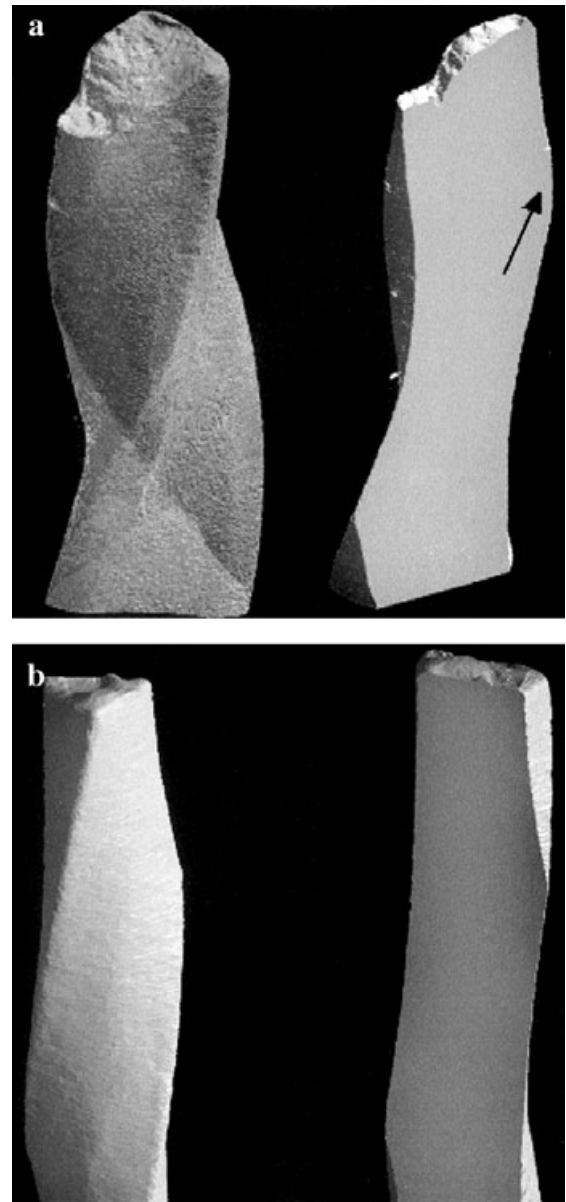
Figure 6(a,b) demonstrate two longitudinal section views of a three-dimensional reconstructed micro-XCT model of two ProTaper endodontic instruments fractured *in vivo*. The left one (Fig. 6a) shows the presence of a secondary crack below the fracture plane without other internal defects.

**Figure 6** Cross sectional views of three dimensional X-ray microtomographic images of two ProTaper endodontic instruments fractured in vivo. a) The presence of a second crack below the fracture plane is evident. b) Despite the fracture there is no evidence of external or internal defects.
